**ANALYSIS OF FAILURE MODES AND MECHANISMS OF DOZER  
BLADE LINERS (DBLs) IN A KIMBERLITE TAILINGS  
ENVIRONMENT AT THE ORAPA DIAMOND MINE IN BOTSWANA**

AMOS ERNEST JERE

A Dissertation/Thesis Submitted to the School of Earth Sciences and Engineering in  
Partial Fulfilment of the Requirements for the Award of the Degree of Master of  
Engineering in Materials and Metallurgy Engineering of BIUST

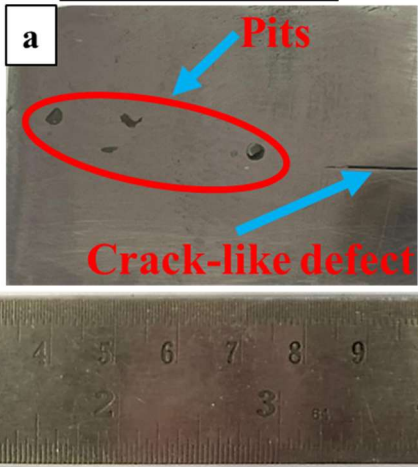
| Failure mode | SAMPLE ID / Image | Macroscopic appearance and morphological characteristics | Causative factors |
|---|---|---|---|
| Inherent defect in the control sample S5 | <div><div>Control sample</div><div><div>a</div></div></div> | <p>Large visible internal pits and possibly inclusions.</p> <p>Crack-like defect (more likely a ‘lap’ defect) characterised by a crevice that runs lengthwise on the DBL.</p> | <p>Presence of inclusions and errors during the manufacturing process.</p> |

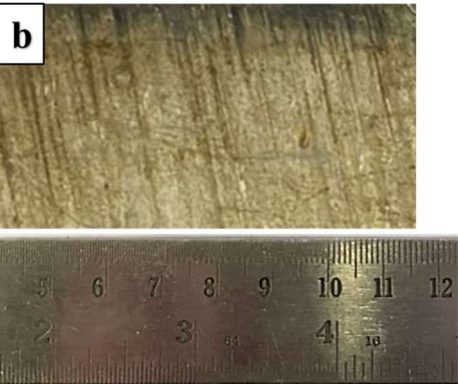
| Failure mode | SAMPLE ID / Image | Macroscopic appearance and morphological characteristics | Causative factors |
|---|---|---|---|
| Abrasive wear (failure mode A in sample S1) | <div><div>b</div></div> | <p>Abrasive wear marks and scratches on the surface.</p> | <p>Quartz, diamond and other abrasive materials in kimberlite tailings which are harder than the liners.</p> |

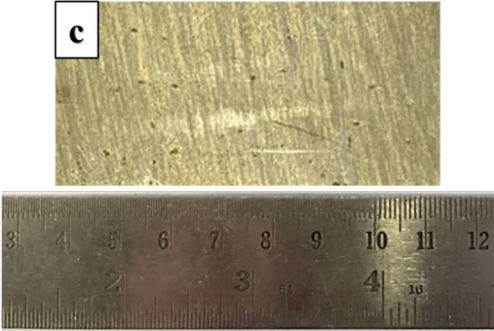
| Failure mode | SAMPLE ID / Image | Macroscopic appearance and morphological characteristics | Causative factors |
|---|---|---|---|
| Pitting (failure mode B in sample S2) | <div><div>c</div></div> | <p>Presence of small cavities or pits on the surface.</p> <p>Roughened surface.</p> | <p>Repeated stresses from sliding of KT on the DBL.</p> |

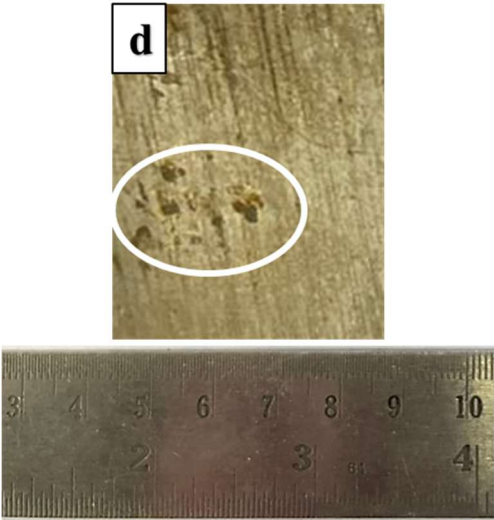
| Failure mode | SAMPLE ID / Image | Macroscopic appearance and morphological characteristics | Causative factors |
|---|---|---|---|
| Deformation (failure mode C in sample S3) | <div><div>d</div></div> | <p>Dent/s on the dozer blade liner’s surface.</p> | <p>High impact load as the DBL comes in contact with the tailings.</p> |

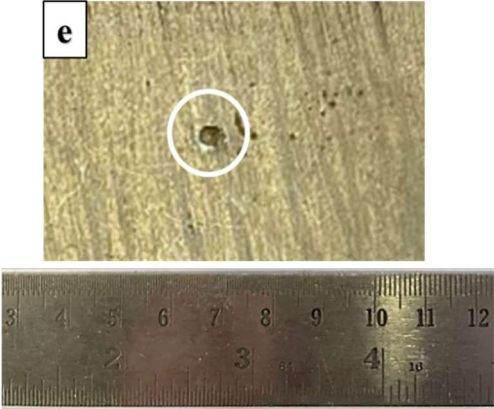
| Failure mode | SAMPLE ID / Image | Macroscopic appearance and morphological characteristics | Causative factors |
|---|---|---|---|
| Spalling (failure mode D in sample S4) | <div><div>e</div></div> | <p>Chipping or flaking of the surface.</p> | <p>Wet tailings.</p> <p>High impact stresses.</p> <p>Surface cracking.</p> |

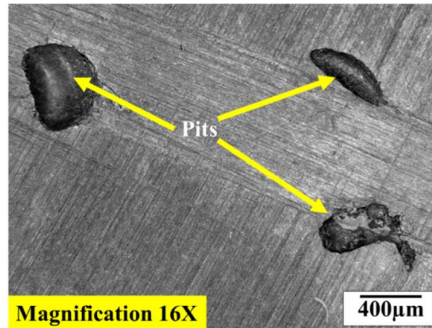
**Figure 4.1:** Stereo microscope micrograph of the control sample S5 showing pits.

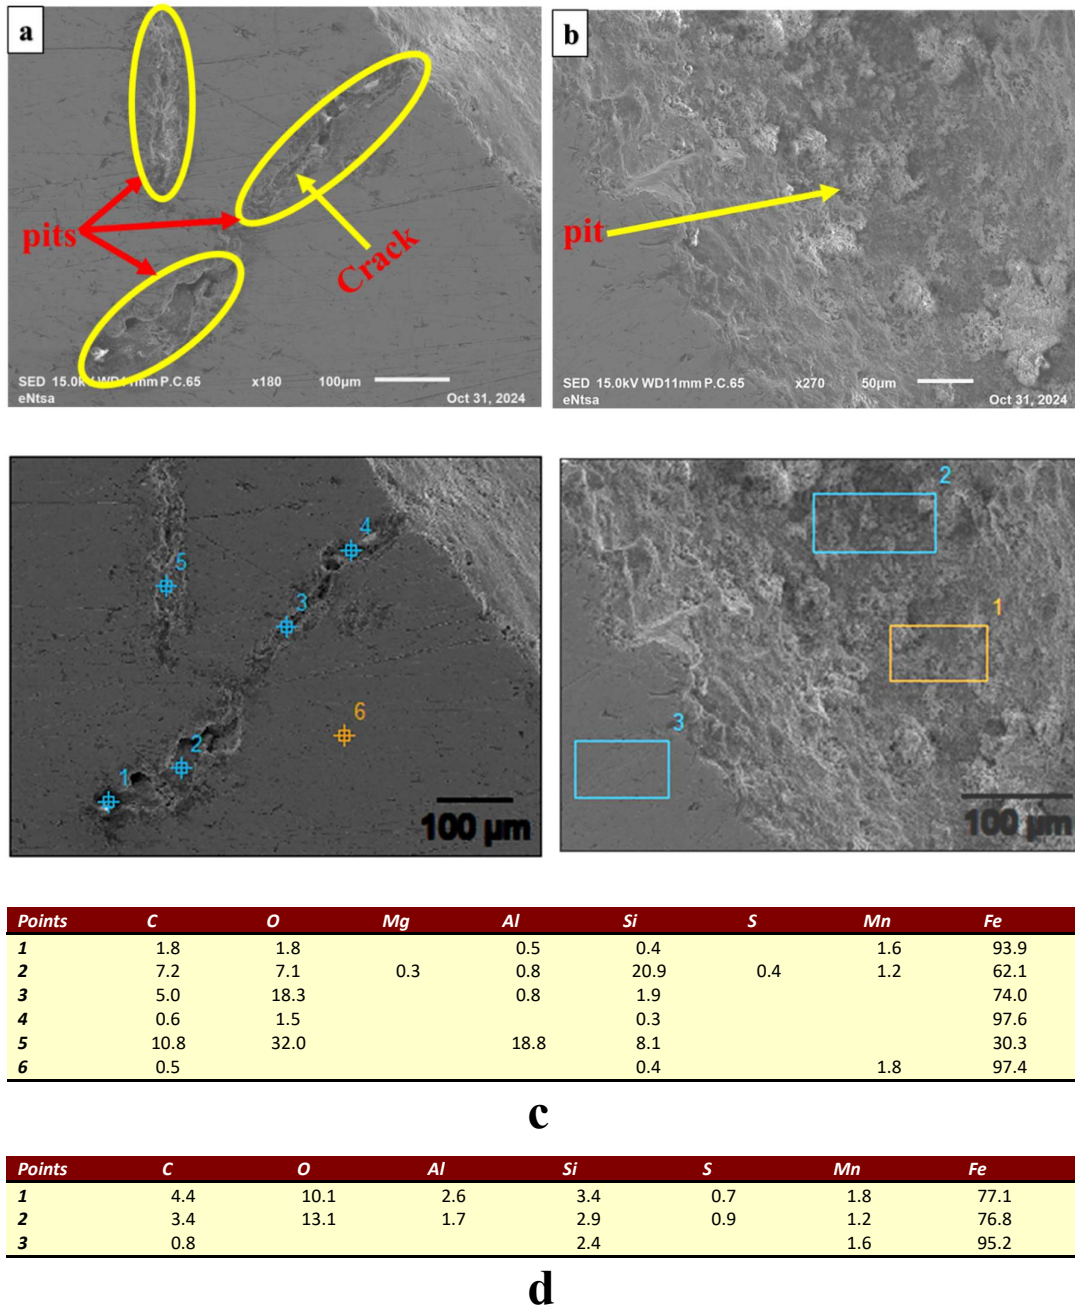
**Figure 4.2.** SEM micrographs of the control sample S5: (a) pit (1), (b) pit (2), (c) EDS spectrum of pit (1), and (d) EDS spectrum of pit (2).

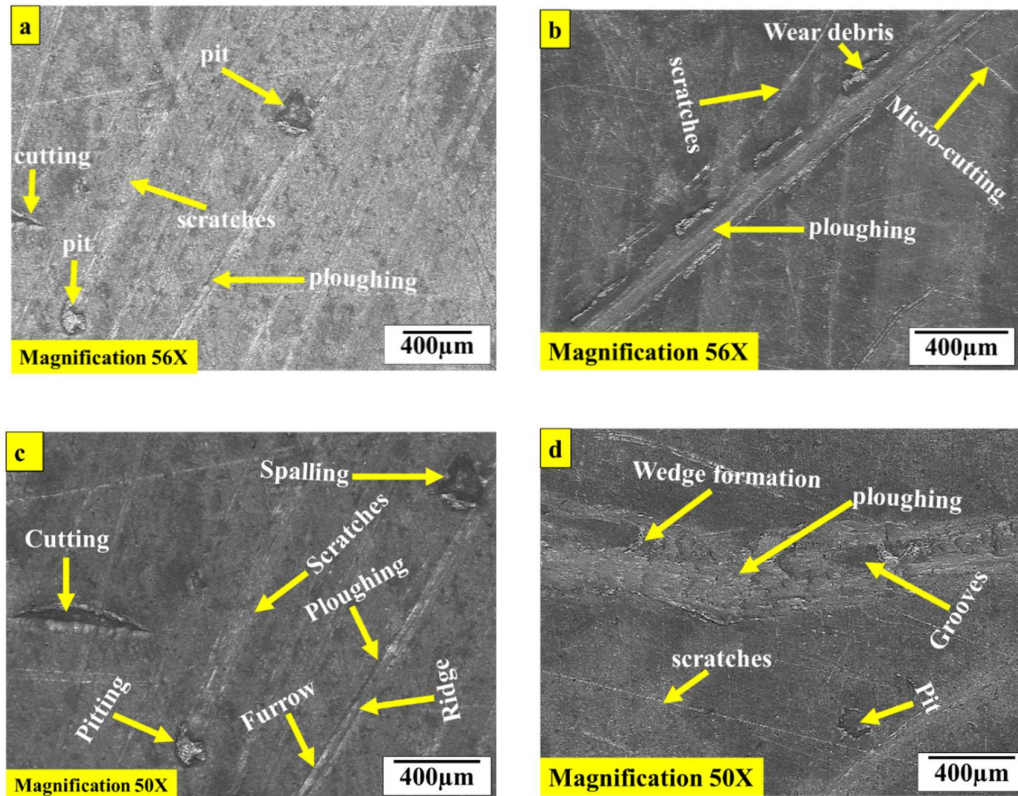
**Figure 4.7:** Stereo microscope micrographs of damaged sample S1 showing abrasive wear mechanisms that led to failure mode A.

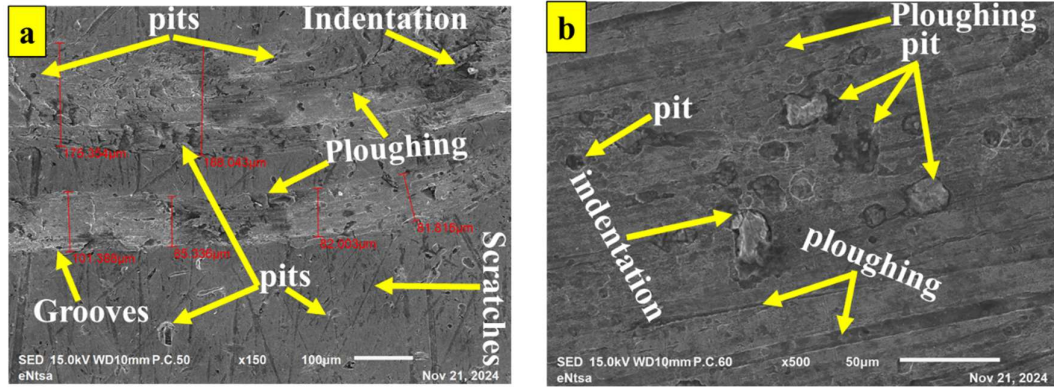
Figure 4.10: SEM micrograph of damaged samples S2 showing pits in DBLs.

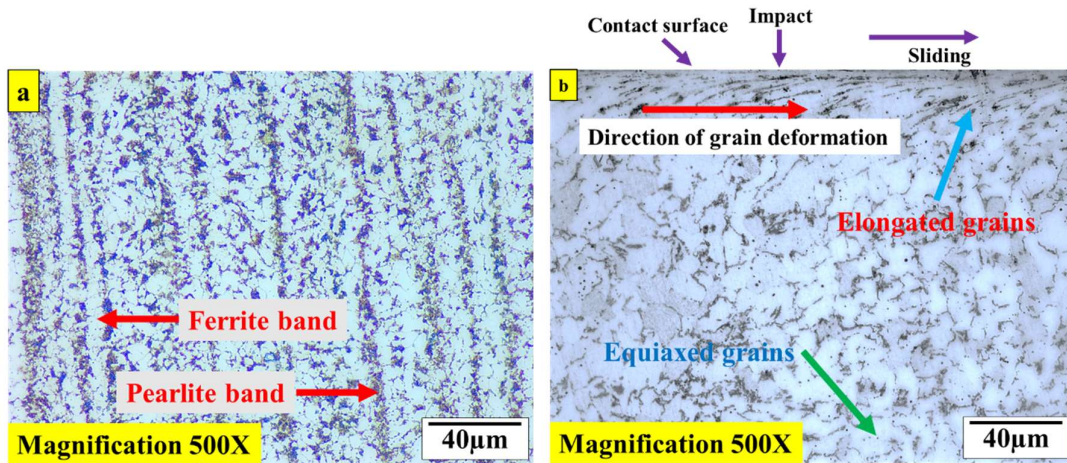
**Figure 4.12:** Optical micrograph of the dozer blade liners (DBLs) sample S3 (a) is the micrograph the worn samples showing a banded structure, and (b) grain deformation in the DBL.

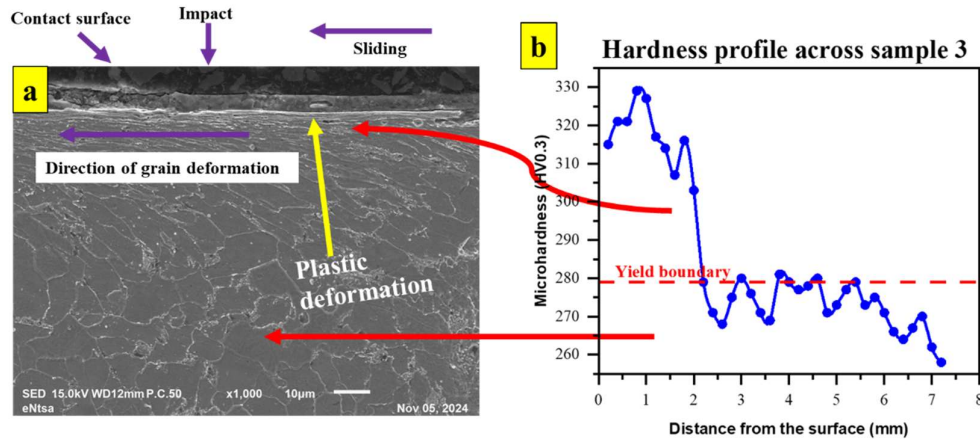
**Figure 4.14:** (a) SEM micrograph of sample S3 cross-section near the failed surface and (b) hardness plot of sample S3.

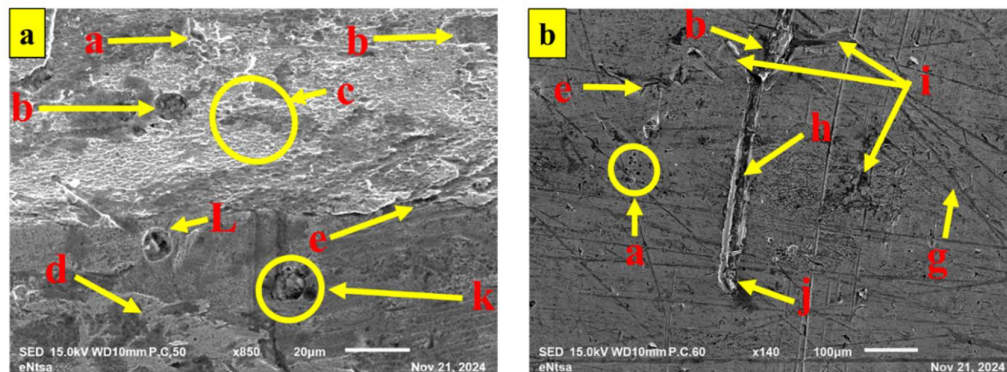
a = Void , b = Spalling, c = Layered delamination, d = Plastic deformation, e = Micro-crack, g = Scratches, h = Ploughing, i = Indentation, j = Material pile up, K = Pits/voids, L = pit
