School of Electrical and Mechanical Engineering  
Department of Mechanical, Energy and Industrial Engineering

**Failure Investigation and Techno-Economic Analysis of Remanufacturing Damaged  
Drive Tumbler of a Diamond Mining Shovel**

A Dissertation/Thesis Submitted to the School of Electrical and Mechanical Engineering in  
Partial Fulfilment of the Requirements for the  
Award of the Degree of Master of Engineering in Industrial and Manufacturing Engineering  
of BIUST

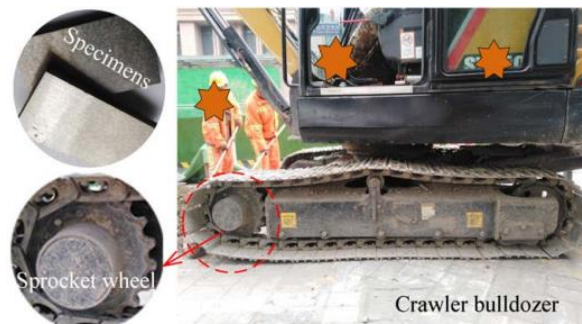
Figure 2.10: Sprocket wheel in contact with crawler Bulldozer chain (Sun et al., 2019; Sobota, 2013)

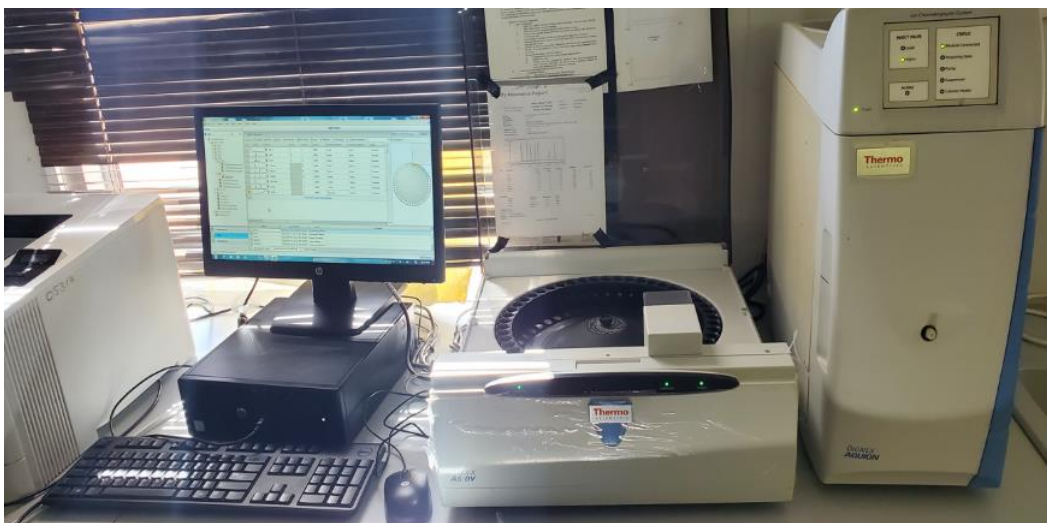
The water sample from the tailing dams in the mine was analysed using H19811-5 water analyser to determine the pH, conductivity, and total dissolved salt (TDS). The Dionex Aquion IC system (Figure 3.5) was used to characterise the anions in the water sample from the mine. A dilution ratio of 1:10 was used to reduce TDS below 1000 mg/L. The water sample was filtered using filter paper of 45 microns to remove any existing particles (Willison & Boyer, 2012). Anions present were then detected, and the plots for each water from the mine are presented and discussed in section 4.1.2. This analysis was carried following ASTM D4327-17 standards for anions in water by ion chromatography.

Figure 3.5: Picture showing Dionex Aquion ion chromatography system

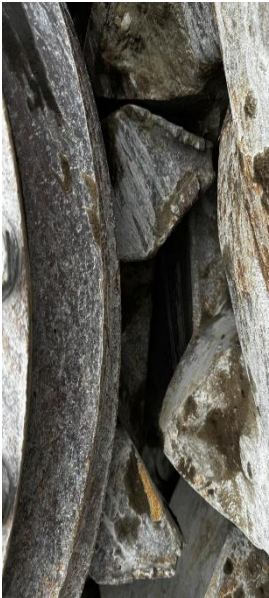
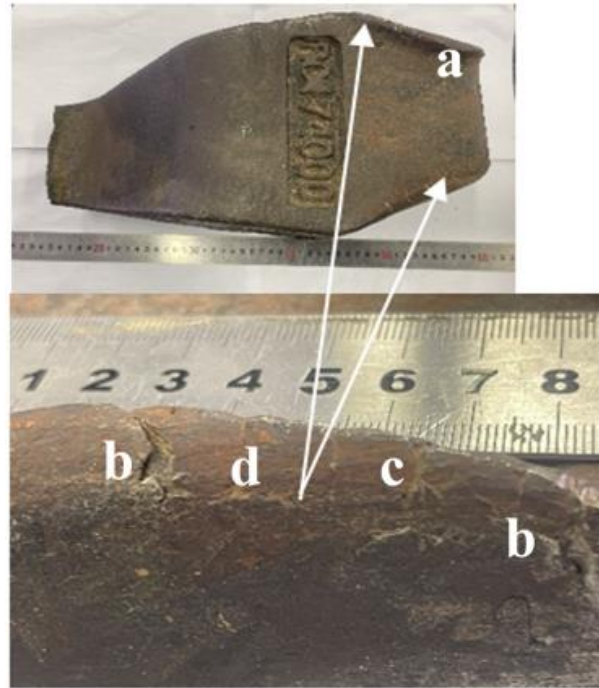
- (a) Edge Warping.
- (b) Cracks on deformed edges.
- (c) Surface wear on the deformed edge.
- (d) Rust on worn surface.
