**ANALYSIS OF FAILURE MODES AND MECHANISMS OF DOZER  
BLADE LINERS (DBLs) IN A KIMBERLITE TAILINGS  
ENVIRONMENT AT THE ORAPA DIAMOND MINE IN BOTSWANA**

AMOS ERNEST JERE

A Dissertation/Thesis Submitted to the School of Earth Sciences and Engineering in  
Partial Fulfilment of the Requirements for the Award of the Degree of Master of  
Engineering in Materials and Metallurgy Engineering of BIUST

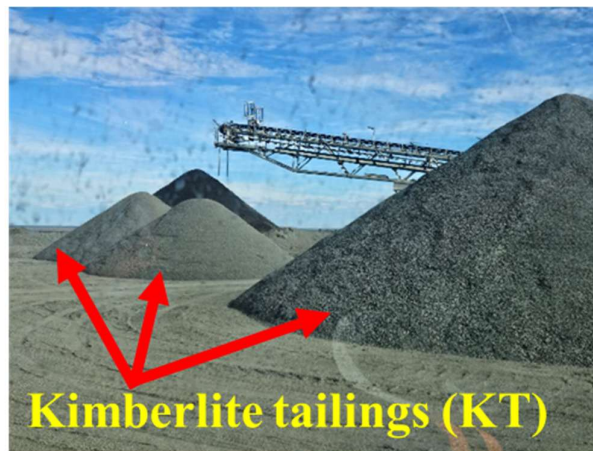
**Plate 1.1:** Piles of Kimberlite tailing particles at the Orapa diamond mine in Botswana.

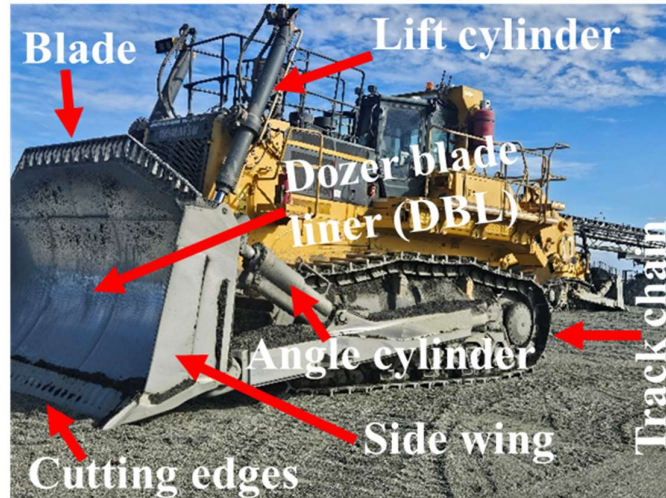
**Plate 1.2:** Picture of a track dozer used at the Orapa diamond mine in Botswana, with DBLs on its blade.

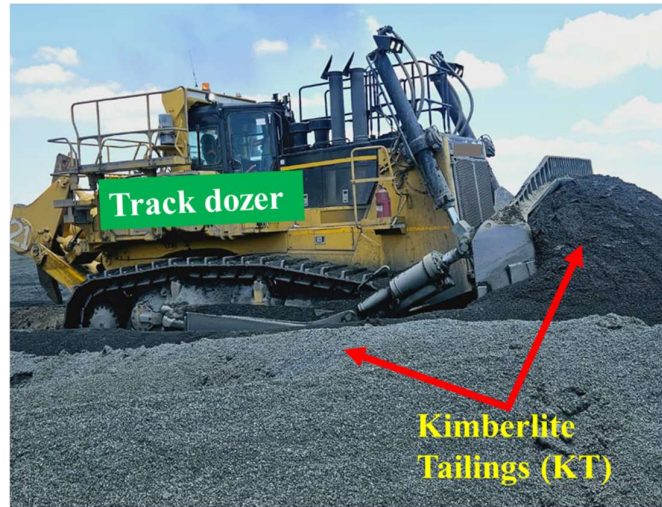
**Plate 2.1:** A track dozer pushing Kimberlite tailing particles at the Orapa diamond mine in Botswana.

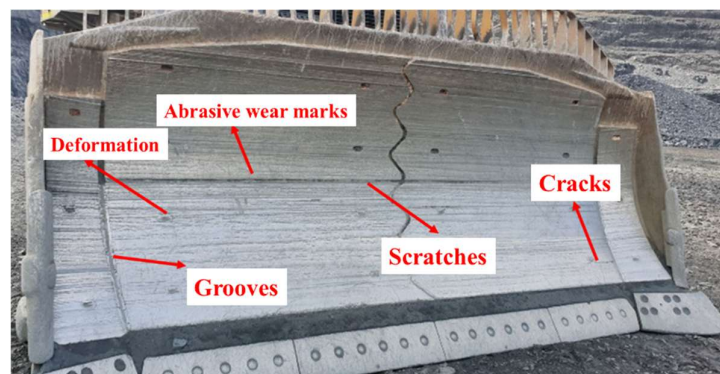
Alojali and Benyounis (2016) described the first mechanism, cutting (**Figure 2.1a**), as a classic model in which a hard asperity penetrates a softer surface, producing wear debris. In cases where the material is brittle, fractures may develop, as illustrated in **Figure 2.1b**. When a ductile material is abraded with blunt grit, cutting is less likely and the surface is repeatedly deformed, leading to wear debris from metal fatigue (**Figure 2.1c**). The final mechanism, shown in **Figure 2.1d**, illustrates grain detachment, where entire grains are lost as wear debris. From **Figure 2.2**, it is evident that the dozer blade liners experienced abrasive wear, as indicated by abrasive wear marks, cracks, deformations, and scratches.

**Figure 2.2:** Abrasive wear in dozer blade liners (Cutting edges, 2020).

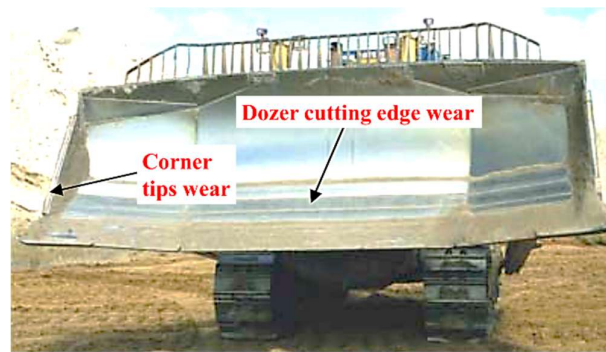
In another study which focused on minimising costs in the mining sector by applying hard surfacing to ground-engaging tools, Chippendale (2000) examined the dozer blades of four Caterpillar D11R machines, identifying blade sections prone to high wear rates. The analysis revealed that the dozer blade cutting edge experiences the most significant wear,

which also influences the cutting efficiency. The study found that the wear mechanisms that affect these edges include a combination of low-stress abrasion, high-stress abrasion, gouging abrasion, polishing wear, and impact erosion. However, Chippendale's work merely listed the wear modes and mechanisms observed on the dozer blade but did not detail the methodology used to reach these conclusions. Operational data from track dozers, along with fractography, optical microscopy, and scanning electron microscopy combined with energy dispersive X-ray spectroscopy (SEM/EDS) should have been utilised to examine microstructural alterations, fracture surfaces, and elemental composition in the worn regions. Incorporating these methods, along with micrographs, operational data, and macrographs, would have offered deeper insight into the root causes of failure. These would have allowed for more targeted material improvements and design optimisations, rather than simply identifying the wear types without a description of how the conclusion was reached.

**Plate 2.3:** Parts of the CAT D11R dozer blade subjected to high wear rates (Chippendale, 2000).

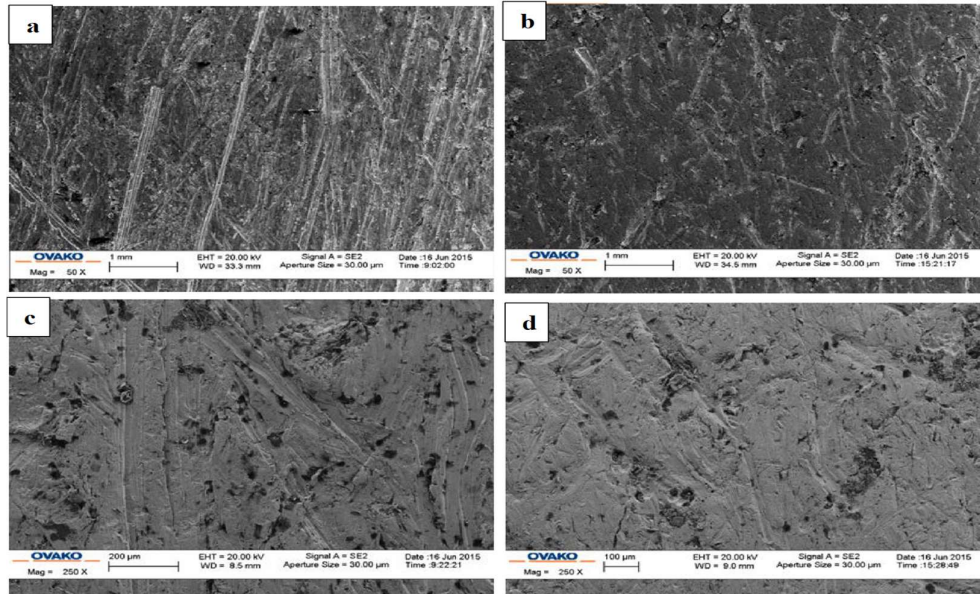
Hylén et al. (2021) reviewed the impact of sliding abrasive wear on a bolt-on edge (BOE) section of a wheel loader bucket to understand the wear mechanisms and the application of wear-resistant steel. SEM image analysis (**Figures 2.3a** and **2.3b**) revealed significant ploughing, wedge formation, and grooves, indicating exposure to sliding abrasive wear. Furthermore, the SEM images (**Figures 2.3c** and **2.3d**) showed that the primary wear mechanisms responsible for material removal were micro-ploughing and micro-cutting. Some areas also exhibited weak fractures, suggesting that the wear mechanism also involved

impact forces. Furthermore, the black spots on both sides were probably due to corrosion, indicating the possibility of wet working conditions. Because the DBLs operate under comparable environmental and loading conditions, similar degradation and wear mechanisms are anticipated.

**Figure 2.3:** SEM micrographs of bottom surface (a), top surface (b) (at a magnification of 50X) and bottom surface (c), top surface (d) (at a magnification of 250X) of the BOE (Hylén et al., 2021).

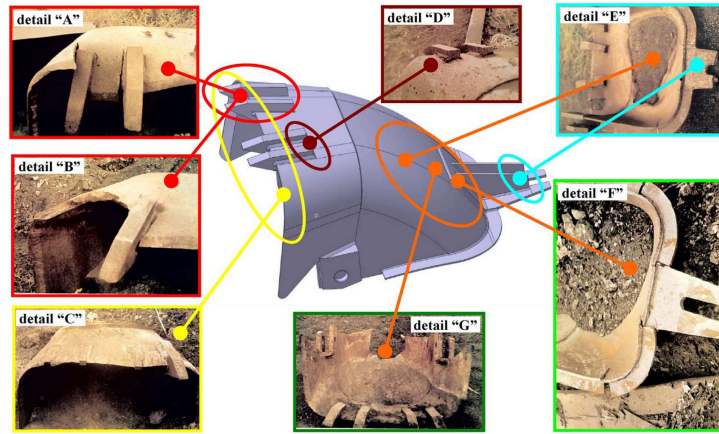
Bošnjak et al. (2018) studied the failure mechanisms of the SRs 470 bucket wheel excavator's buckets by employing ANSYS simulations to assess the operational stresses. The study revealed that the primary failure causes were "design-related defects," which originated from errors in geometric design and material selection. Additionally, increased residual stress and cold cracking at the welded joint between the knife and the bucket body highlighted the presence of "manufacturing-related defects." These combined design and manufacturing problems led to the initiation and propagation of fatigue cracks over time, eventually causing the buckets to fail. **Plate 2.4** shows damage to the bucket structure.

**Plate 2.4:** Failure of the buckets' structure: details A, B, C, D – failure of the teeth and knife; details E, F, G – failure of the buckets' back and zones of rear wedge fastening (Bošnjak et al., 2018).

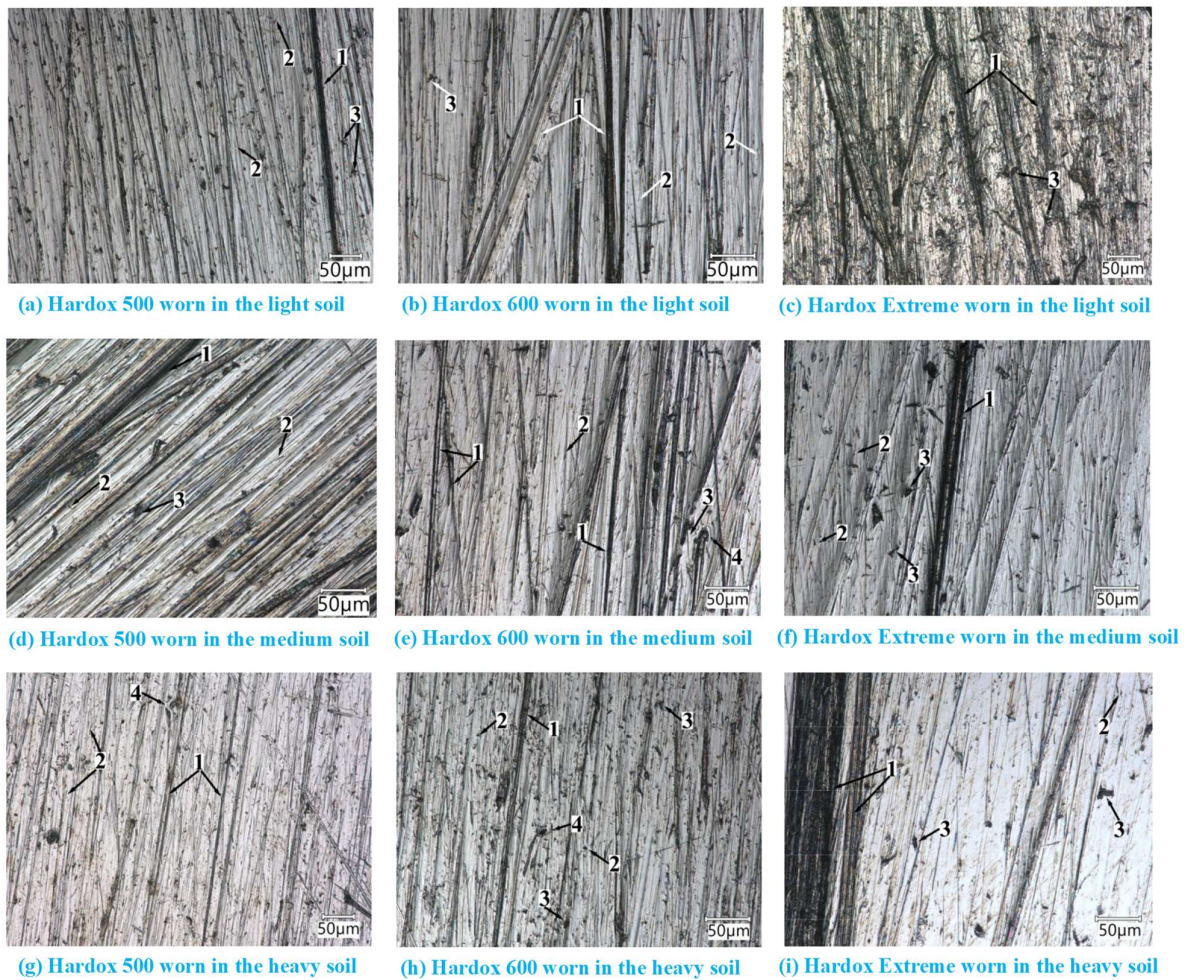
Ligier et al. (2022) analysed the wear properties of various Hardox steels, including Hardox 500, Hardox 600, and Hardox extreme under different soil conditions, emphasising how soil composition affects wear mechanisms. In light soil, the main wear patterns observed for Hardox 500 steel (see **Figure 2.9a**) were characterised by scratching, ridging, and partial removal of material from grooves. Chipping occurred due to microfatigue induced by cyclic impacts of the sand grains, identified as fatigue wear, with some plastic deformation also observed. In medium and heavy soils (**Figure 2.9d** and **Figure 2.9g**), similar types of wear was present but with more intense damage, characterised by pronounced mechanical impact patterns. Hardox 600 steel, despite its increased hardness compared to Hardox 500, exhibited scratching, ridging, and fatigue wear in light soil (**Figure 2.9b**). In medium soil (**Figure 2.9e**), the wear patterns were similar, but the ridging intensity was notably higher. In heavy soil (**Figure 2.9h**), chipping, ridging, and microcutting dominated, driven by mechanochemical wear facilitated by the soil's composition. Hardox extreme steel in light soil (**Figure 2.9c**) showed deep and wide ridging traces, followed by plastic deformation and material tear-up. In medium soil (**Figure 2.9f**), the effects of ridging and microcutting were more pronounced than in other materials. In heavy soil (**Figure 2.9i**), wear was characterised by prominent wide and deep grooves, reflecting significant material loss. The

**Figure 2.9:** The surfaces of the Hardox steel samples subjected to wear in various soil types observed by light optical microscopy: (a) Hardox 500 worn in the light soil, (b) Hardox 600 worn in the light soil, (c) Hardox Extreme worn in the light soil, (d) Hardox 500 worn in the medium soil, (e) Hardox 600 worn in the medium soil, (f) Hardox Extreme worn in the medium soil, (g) Hardox 500 worn in the heavy soil, (h) Hardox 600 worn in the heavy soil, (i) Hardox Extreme worn in the heavy soil. The surface features are labeled as: 1 - ploughing, 2 - microcutting, 3 - chippings, and 4 - plastic deformation. (Ligier et al., 2022).

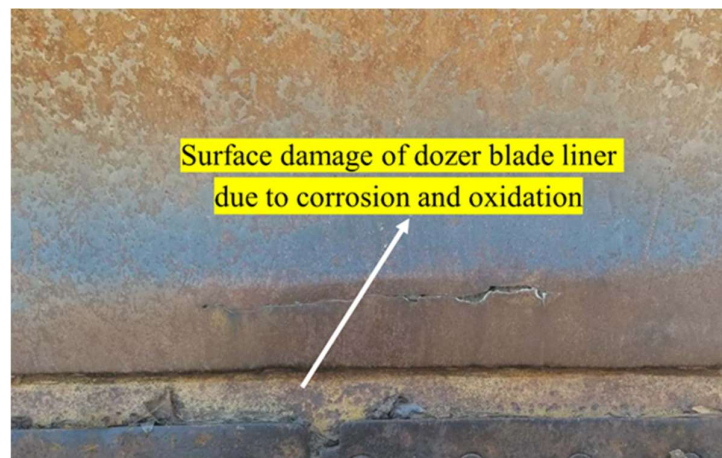
Corrosion mechanisms involve the formation of protective films, sacrificial layers, and rapid corrosion (Stachowiak & Batchelor, 2005). According to Alojali and Benyounis (2016), presence of fine corrosive products on surfaces contribute to the generation of wear particles during corrosive wear. When these protective layers are disrupted or removed by sliding or abrasion, fresh metal is exposed, and a new layer begins to form, creating a continuous cycle of removal and formation. Corrosive agents such as water, seawater, oxygen, acids, and atmospheric gases like hydrogen sulphide and sulphur dioxide play a key role in these processes (Kalpakjian & Schmid, 2022). In corrosive wear, tribochemical reactions form a reactive surface layer that is gradually worn away by friction. The wear rate depends on the balance between the formation and removal of these reactive layers. **Figure 2.10** shows the corrosive and oxidation wear observed on a dozer blade liner from a Caterpillar D8 bulldozer.

**Figure 2.10:** Corrosive and oxidation wear of a dozer blade liner for caterpillar D8 bulldozer (WeldingWeb artisan, 2021).

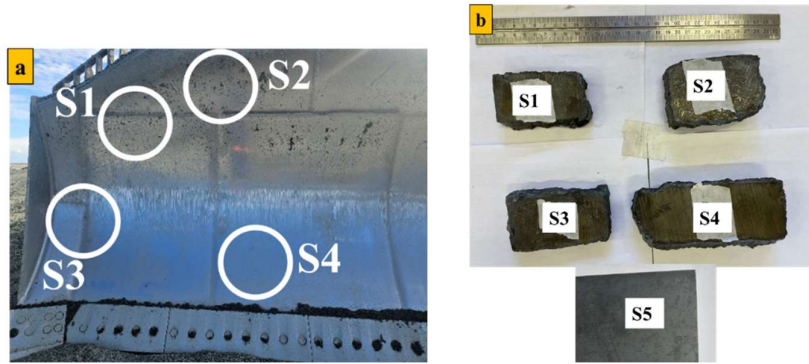
**Plate 3.1:** (a) Dozer blade covered with lining plates, highlighting the sampling areas. (b) Extracted DBL samples S1, S2, S3, S4, and S5.

Visual examination of the worn DBL samples (seen in **Plate 3.1b**) revealed the following failure modes, detailed in **Table 4.2**: abrasive wear (failure mode A), pitting (failure mode B), deformation (failure mode C), and spalling (failure mode D). Control sample S5, when cut crosswise, revealed inherent defects such as pits and cracks, which may indicate inherent manufacturing defects. Examination of the control sample S5 at both macroscopic and microscopic levels is crucial for setting a reference point, allowing differentiation between manufacturing defects and those caused by operational conditions. This analysis is essential

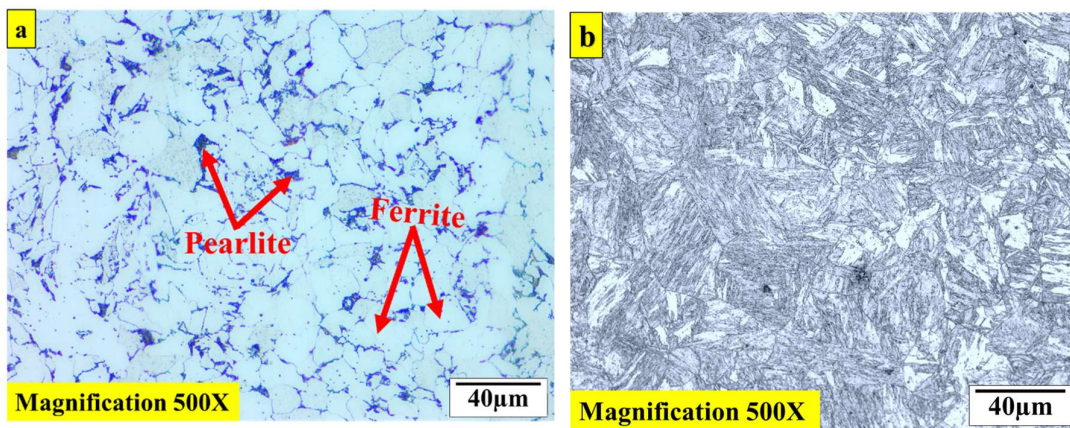
**Figure 4.4:** Microstructural analysis of control sample S5: (a) Optical micrograph at 500X reveals ferrite and pearlite structure; (b) Optical micrograph at 500X reveals a uniform tempered martensitic structure in rapidly quenched regions.

The optical micrograph of control sample S5 (**Figure 4.4a**) shows a predominantly ferritic and pearlitic microstructure, typical for low-carbon steels with the given chemical composition (see **Table 4.1**). Ferrite, which appears as light regions, is soft, ductile, and has a body-centered cubic (BCC) structure (Vander Voort, 2015). The low carbon content (0.12%) promotes a significant amount of ferrite. The darker regions represent pearlite, a

The expected microstructure is primarily ferrite with some pearlite; however, a minor amount of uniform auto-tempered lath martensite was observed in certain regions, likely

due to rapid cooling from austenite. **Figure 4.4(b)** shows the microstructure of control sample S5, which consists of a uniform tempered martensitic structure characterised by a homogeneous distribution of fine acicular (needle-like) features, typical of wear-resistant steels (Bayram et al., 1999). This structure enhances toughness and hardness (Callister, 2007). The martensitic transformation (**Figure 4.4b**) resulted from rapid quenching and tempering, which improve hardness and wear resistance (Gharbi et al., 2021). This is because the steel plates are produced through casting, followed by hot rolling. (He, 2015). These findings align with (Militzer, 2014), who reported that sufficiently fast cooling (quenching) of ferrite-pearlite steels promotes martensite formation. However, the demanding operating conditions of the DBLs, combined with the significant sliding abrasion on the DBLs, lead to premature wear, as indicated by the wear modes outlined in **Table 4.2**. Consequently, the performance is compromised, and its quality deteriorates. Therefore, an alternative material with an optimal balance of superior hardness and adequate abrasion resistance is required for this application.

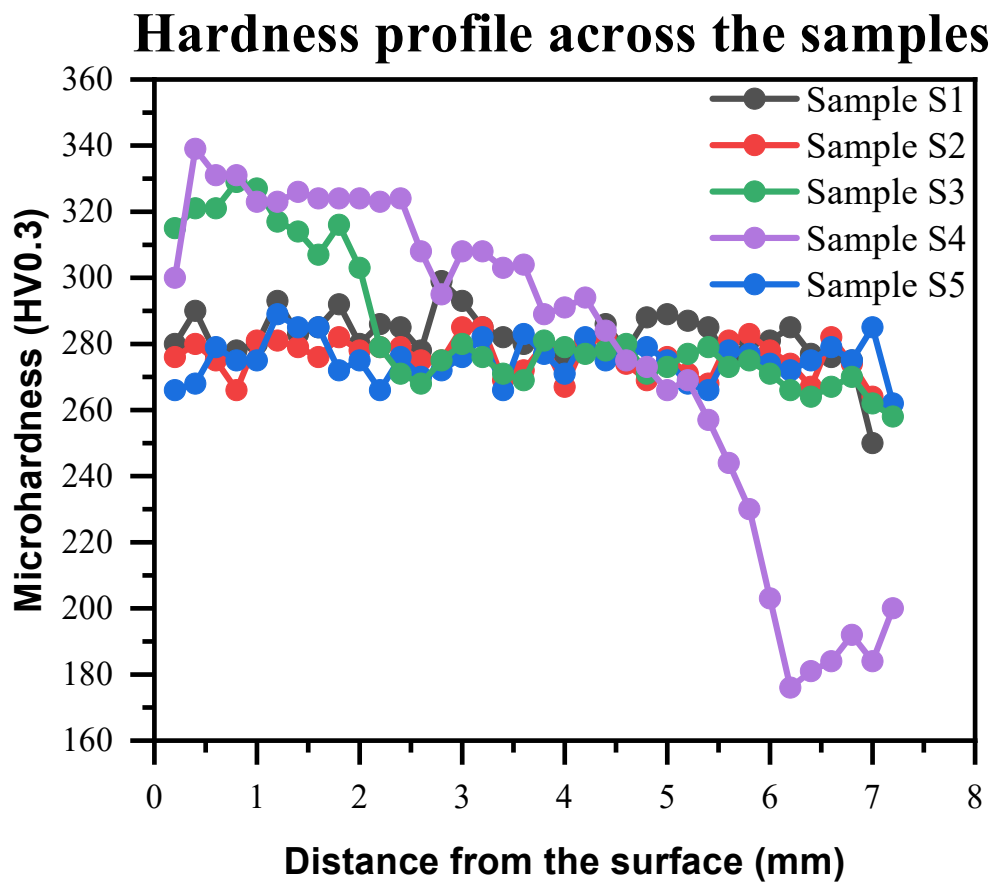
**Figure 4.5:** Microhardness profile across the DBL samples.

The microhardness analysis aimed to determine the level of degradation that the damaged DBLs have been subjected to after wear, and the results are summarised in **Figure 4.5**. The microhardness of the damaged samples showed a different trend from that of the control sample S5. The control sample S5 (blue curve) maintains stable microhardness across the entire distance from 0 to 7.2 mm. The values fluctuate slightly within the 285-264 HV<sub>0.3</sub> range, and show no significant upward or downward trend. This consistency suggests that the control sample maintains uniform material properties throughout its depth, serving as a reliable reference for comparison.

Damaged samples (S1, S2, S3, and S4) show different degrees of degradation as a result of wear. Sample S4 initially hardens (300-339 HV<sub>0.3</sub>) due to work hardening from repeated impact and sliding against kimberlite tailings (KT). However, its hardness drops sharply 2.8

mm from the surface, though it remains higher than that of the control sample (S5). This may be attributed to potential microstructural changes. At 4.6 mm from the surface, the hardness of sample S4 falls below that of the control sample (S5), indicating severe wear, material softening, and potential microstructural changes, such as phase transformations, leading to material failure (see **Figure 4.12a**). This was also evident in the work of Lindroos et al. (2015) which investigated wear behaviour and work hardening of high strength steels under high stress abrasion. While work hardening can temporarily improve the hardness and wear resistance of steel components, continuous exposure to high-stress abrasive environments can lead to microstructural degradation and eventual failure (Olawale et al., 2013). Sample S4 was extracted from a region closer to the cutting edges (metal plates at the bottom of the blade that make direct contact with the ground) where stress levels are high (see **Plate 3.1a**). This explains the increased hardness values observed across all samples and the severe wear behaviour of sample S4. (Mahto & Mastorakis, 2016) confirmed that stress levels are highest at the dozer blade cutting edges and the areas adjacent to them compared to other portions of the blade. On the contrary, samples S1 and S2 exhibit relatively stable hardness (299-250 HV<sub>0.3</sub>) and (289-266 HV<sub>0.3</sub>), slightly above control sample S5, suggesting strain hardening has slightly improved wear resistance. This pattern highlights the progressive wear of the dozer blade liner, with some areas experiencing accelerated degradation due to high-stress abrasion and material loss. The reduced hardness variation in S1 and S2 can be attributed to their location, which is closer to the top of the dozer blade and farther from the cutting edges (see **Plate 3.1a**).

However, sample S3 undergoes work hardening (335–279 HV<sub>0.3</sub>) from 0 to 2.2 mm due to the sliding action of kimberlite tailings, which roughens its surface. Beyond 2.2 mm, the hardness decreases from 279 to 258 HV<sub>0.3</sub>, indicating that the core of the DBL remains unaffected, while the area closer to the region of contact with the KT particles has been work-hardened. Sample S3 was extracted from the middle portion of the blade (see **Plate 3.1a**); hence, it has a higher hardness than Sample S1 and S2 but a lower hardness compared to Sample S4. This observation is supported by the works of (Chippendale, 2000; Mahto & Mastorakis, 2016), who observed that the highest stress intensity occurs at the dozer blade's cutting edge and its surrounding areas. These are the primary zones where wear rate and stress levels are high, as most interaction with the material (kimberlite tailings) occurs in this region compared to the top part of the blade. Additionally, a bulk hardness test using a

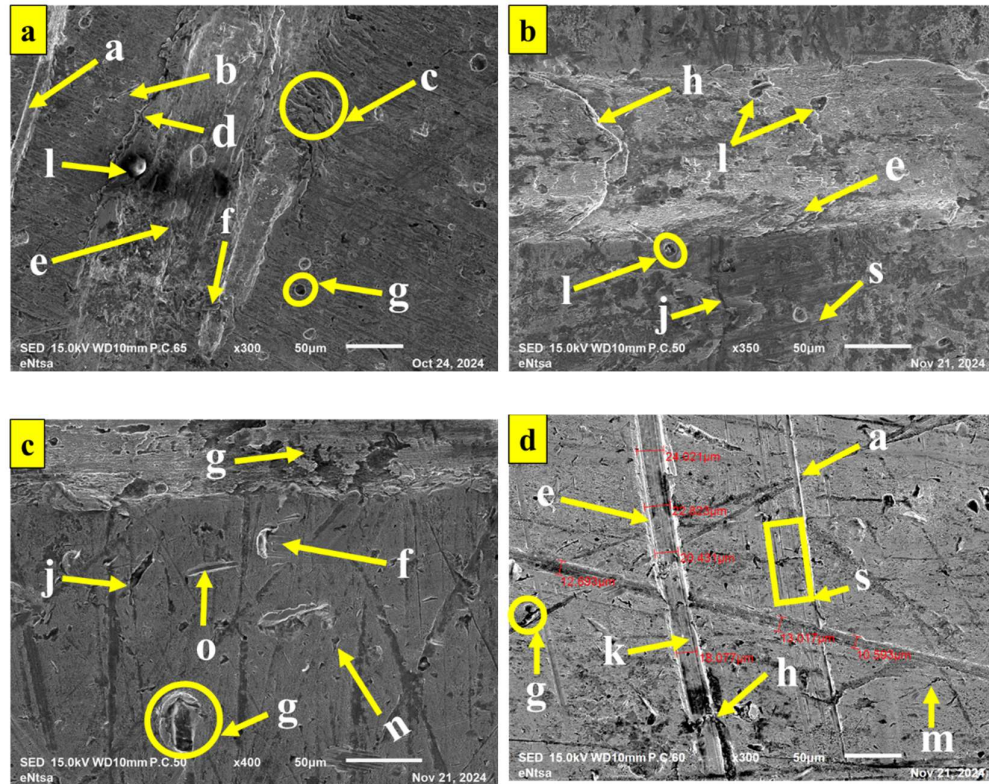
**Figure 4.8:** SEM micrograph of damaged samples S1 showing abrasive wear mechanisms in DBLs.

The minor ploughing (grooves) observed on the worn surface (as seen in **Figures 4.8a, 4.8b,** and **4.8d**) suggests that the abrasion process was primarily driven by abrasive sliding of kimberlite tailings (KT) particles-two-body abrasive wear. Two-body abrasive wear is caused by abrasive particles or asperities that are rigidly attached to the second body. Due to this, the abrasive particles in a two-body mechanism can penetrate deeply into the workpiece material (Marinescu et al., 2013). In this case, the higher hardness of the KT particles compared to that of DBLs results in deep cuts or scratches on the DBLs, resulting

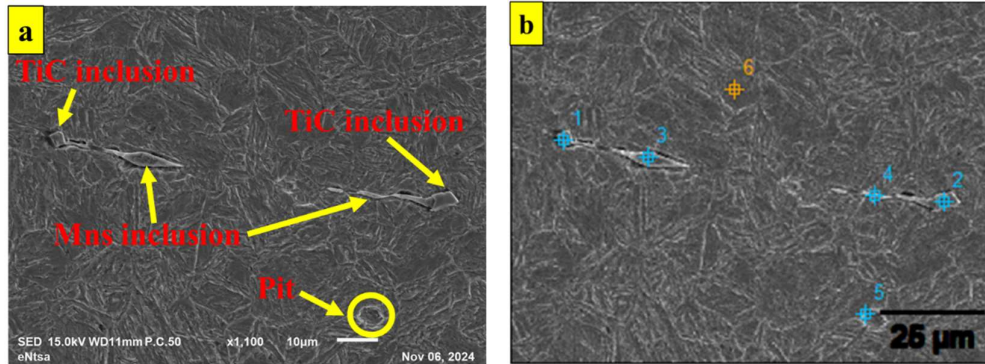
The SEM micrograph (**Figure 4.9a**) taken from sample S1 highlights an elongated manganese sulphide (MnS) inclusion, which affects mechanical properties and wear resistance of steels. The shape of MnS inclusions in low carbon, low alloy steels is typically elongated as MnS stringers (Mahmutović et al., 2017). Using SEM EDS, it was confirmed that the inclusion was manganese sulphide as shown on **points 3 and 4** in **Table 4.3**. Manganese sulphide inclusions have been found to be softer than the steel matrix, and they act as stress raisers, resulting in higher stress concentrations and leads to crack initiation sites under loading (Arreola-Herrera et al., 2018).

Under high stress, inclusions gradually separate from the metal matrix grains, leading to micro-damage, primarily in the form of micro-voids (Kyekyere et al., 2024). Additionally, stresses within the metal are transferred to the softer inclusions (MnS), causing microcrack

formation within the inclusions and subsequent crack propagation along their interface with the metal matrix. **Table 4.3** shows the EDS spectra for **Figure 4.9b**, an SEM micrograph indicating regions (1–6) sampled for elemental composition analysis.

**Figure 4.9:** (a) SEM showing MnS and TiC inclusions within the microstructure, (b) SEM micrograph indicating regions (1-6) sampled for elemental composition analysis.

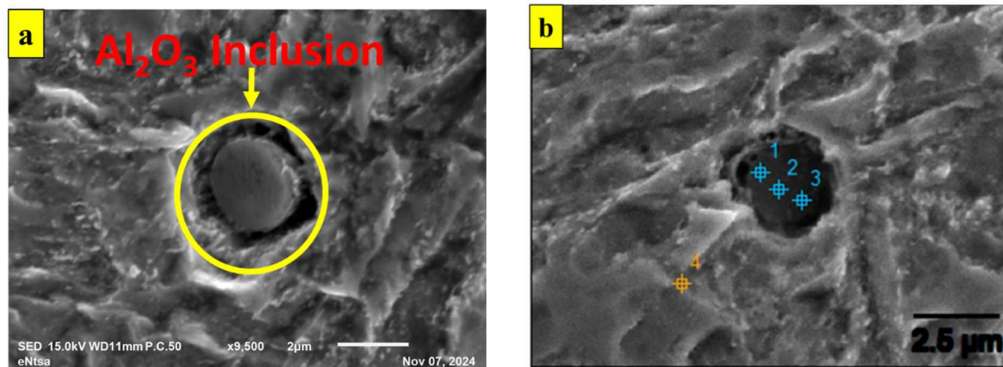
Furthermore, SEM and EDS analysis (**Table 4.4**) of sample S2 revealed the presence of  $\text{Al}_2\text{O}_3$  inclusions (see **Figure 4.11a** and **Figure 4.11b**).  $\text{Al}_2\text{O}_3$  inclusions (globular shape) are generally considered harmful because they have low toughness, therefore, brittle and act as crack initiation sites (Kumar Sarna, 2021; Lecomte-Beckers et al., 2001).

**Figure 4.11:** (a) SEM micrograph of sample S2 showing  $\text{Al}_2\text{O}_3$  inclusion and (b) SEM micrograph of distinct areas (1-3) analysed for compositional variation.

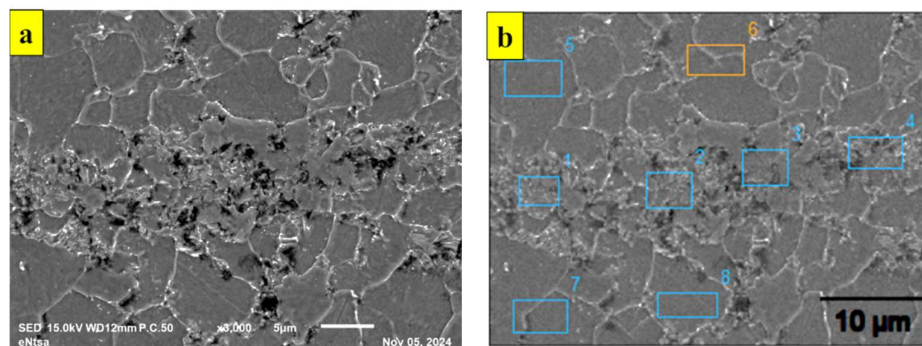
SEM analysis of sample S3 revealed a banded structure of the surface to complement the optical microscopy results (see **Figure 4.13a**). **Figure 4.13b** shows the SEM micrograph of sample S3 banding region, showing distinct areas analysed for microstructural and compositional variation (regions 1–8). **Table 4.5** shows the EDS spectrum of Sample S3, banding region #4, highlighting the elemental composition with peaks for Fe, Mn, Cr, Si, and C.

**Figure 4.13:** (a) SEM micrographs of sample showing banded structure of sample S3, (b) SEM micrograph of distinct areas analysed for microstructural and compositional variation

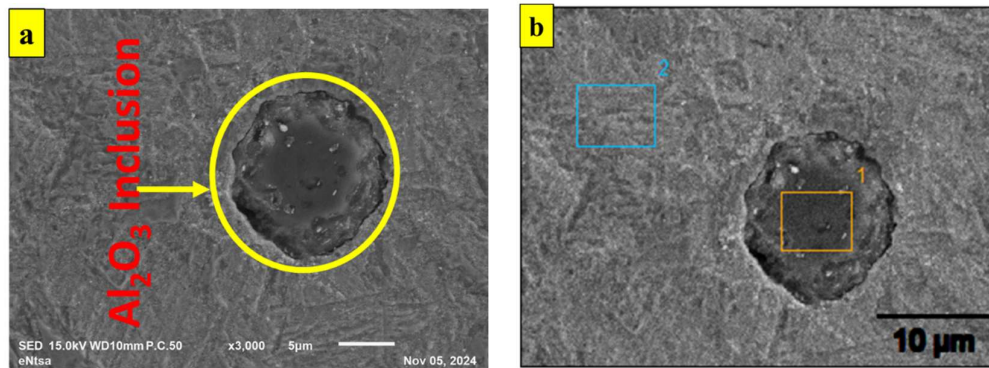
The micrographs (**Figure 4.16a** and **Figure 4.16b**) corresponding to sample S4 highlight areas of material displacement and embedded particles, with regions showing intact and heavily eroded zones. This reflects localised variations in resistance to mechanical wear. The high carbon content in **Table 4.6** could imply the presence of diamond in the pit as discussed in **Table 4.3**. EDS spectrum at point 1 confirms the presence of aluminium and oxygen, indicating an aluminium oxide inclusion (**Figure 4.16a**). The presence of aluminium oxide inclusions as discussed earlier can act as stress concentrators, leading to crack initiation and propagation under cyclic sliding (Arreola-Herrera et al., 2018). Additionally, these hard inclusions may contribute to abrasive wear, accelerating material degradation.

**Figure 4.16:** (a) SEM micrograph showing  $\text{Al}_2\text{O}_3$  inclusion within the microstructure of sample S4, (b) SEM micrograph indicating regions (1-2) sampled for elemental composition analysis.
